## APPENDIX I

### CONCRETE TESTING

RE: Peavey Plaza Fountain Rehab  
Nicollet Mall  
Between 11<sup>th</sup> and 12<sup>th</sup> Streets South  
Minneapolis, Minnesota  
Thin Section Analysis  
AET Project No. 05-06658

## SITE VISIT REPORT

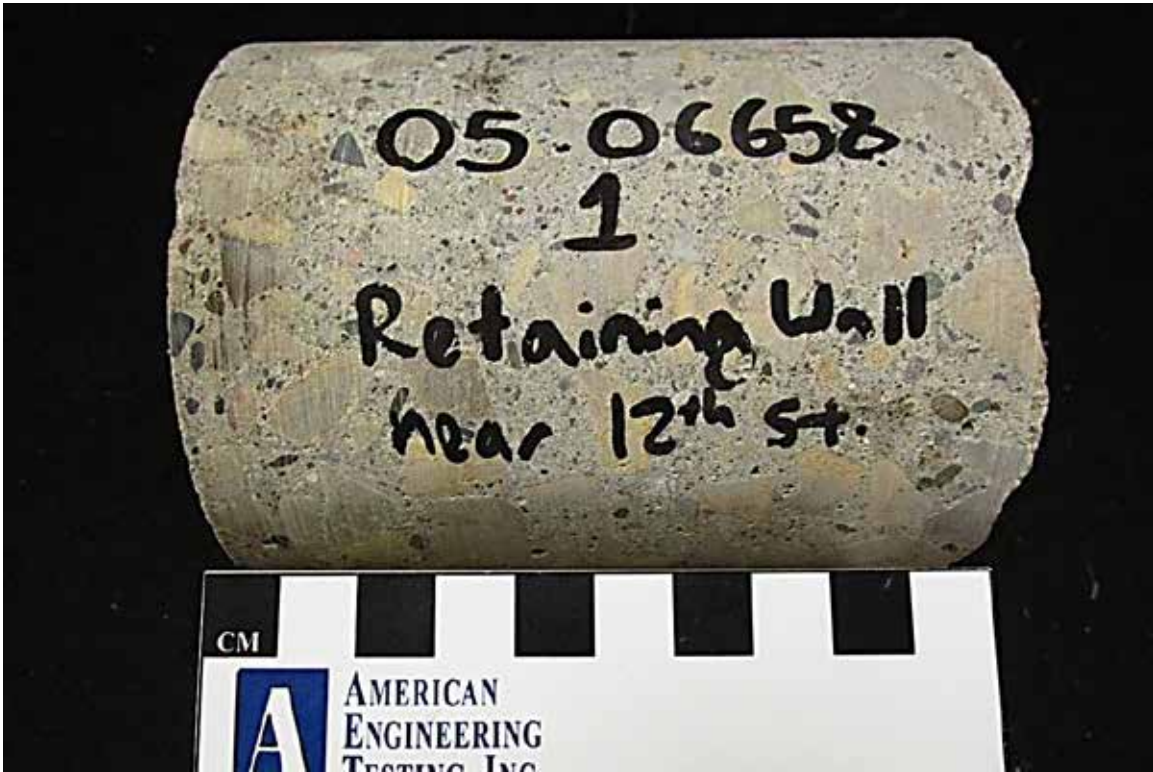
PHOTO: 1

SAMPLE ID: 1      DESCRIPTION: Overall profile of the core as received, with the outer surface oriented to the left.

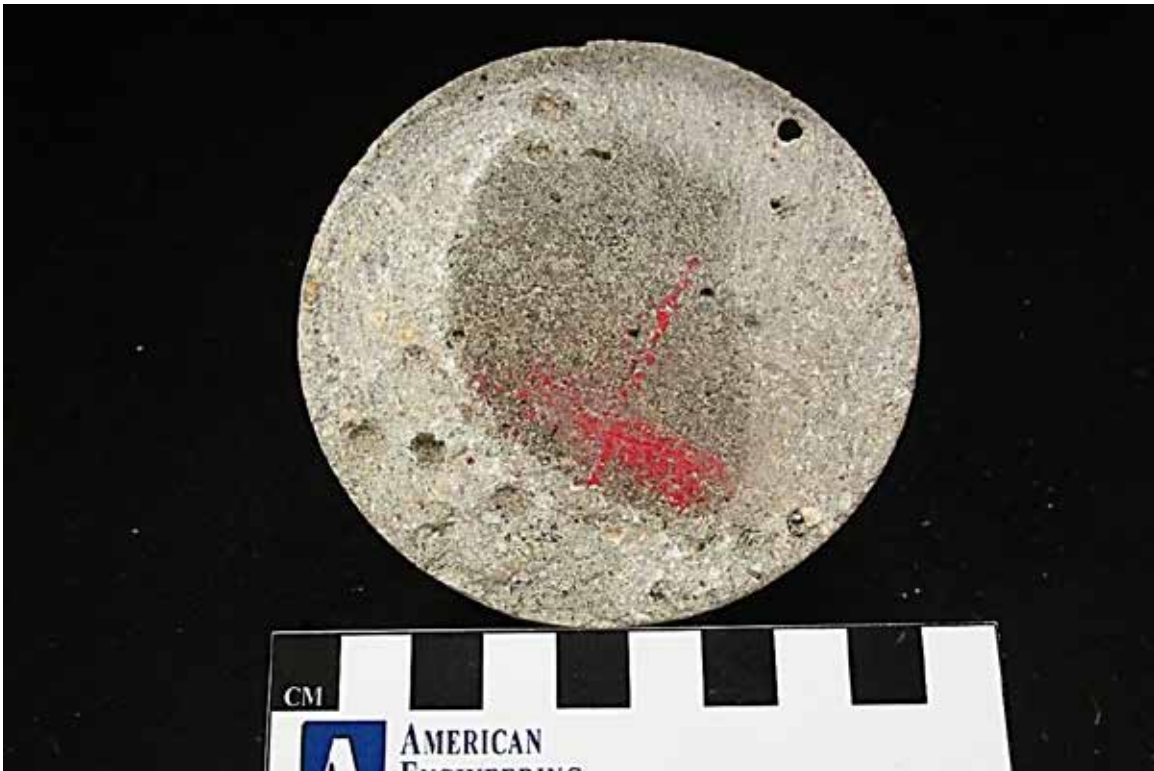
PHOTO: 2

SAMPLE ID: 1      DESCRIPTION: Outer surface of the core as received. Much of the formed outer surface has been shallowly ground away during coring.

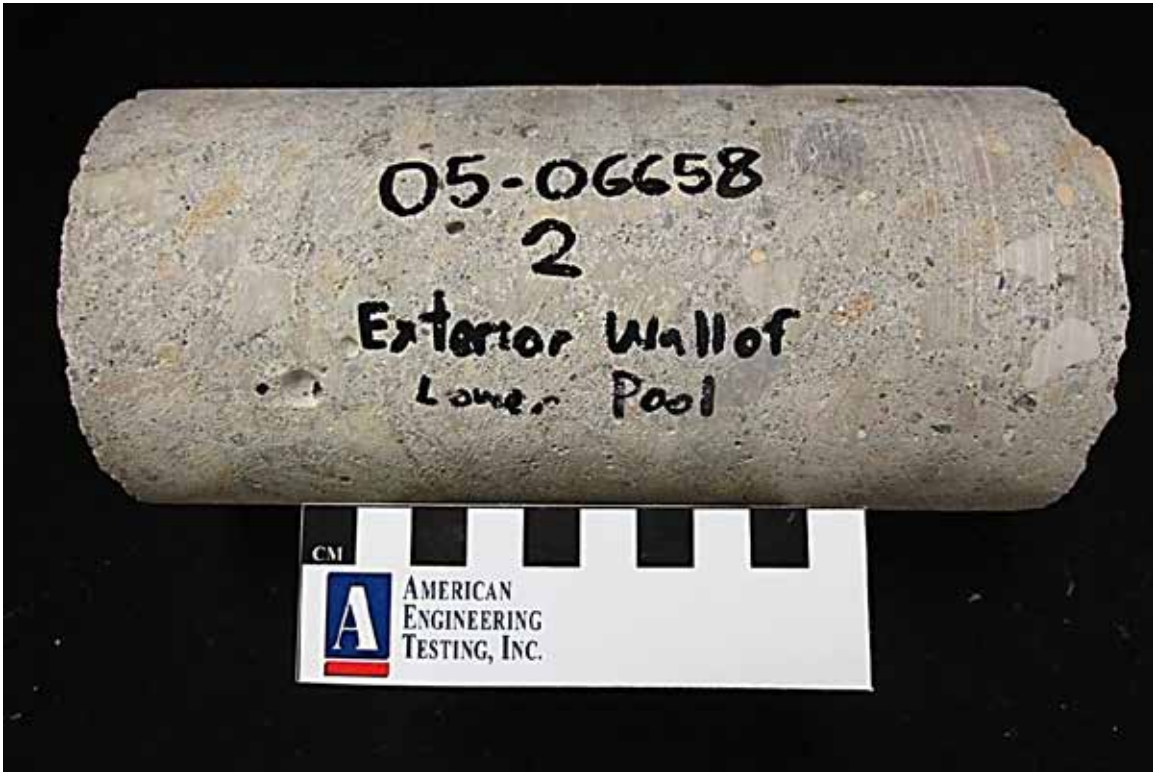
PHOTO: 3

Overall profile of the core as received, with the outer surface oriented to the left.

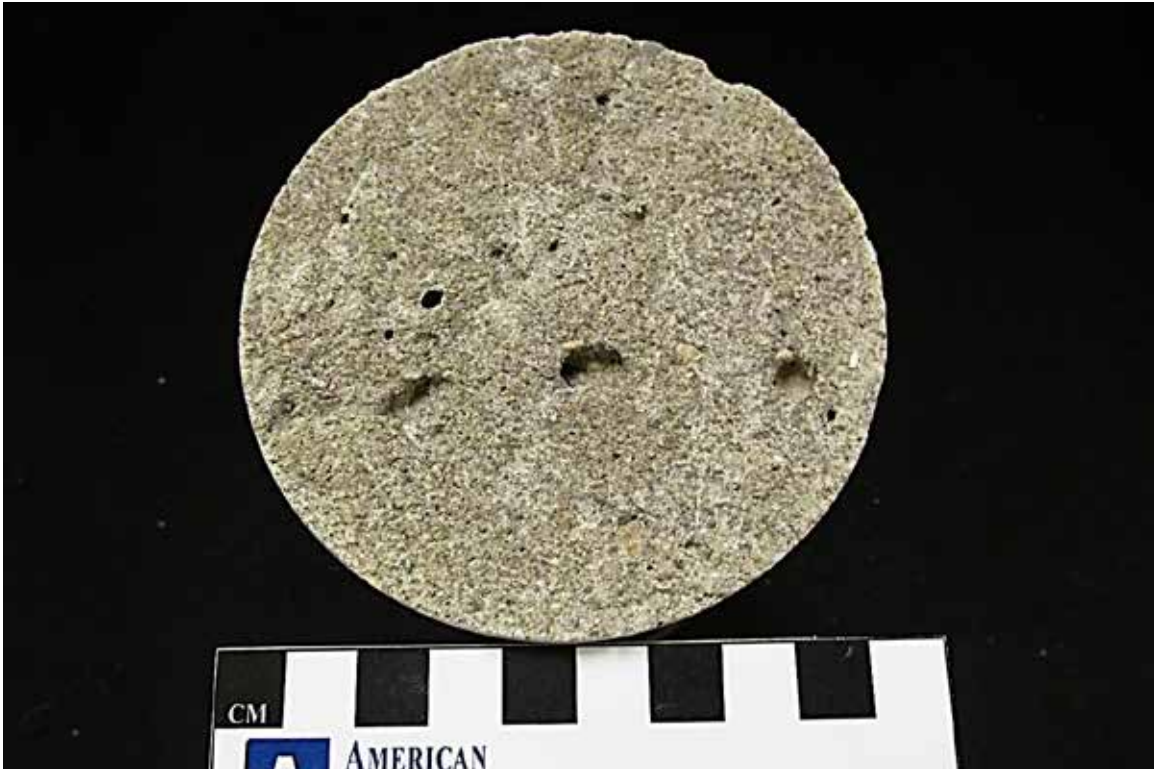
PHOTO: 4

The formed outer surface of the core as received. Minor mortar erosion has exposed many fine aggregate particles.

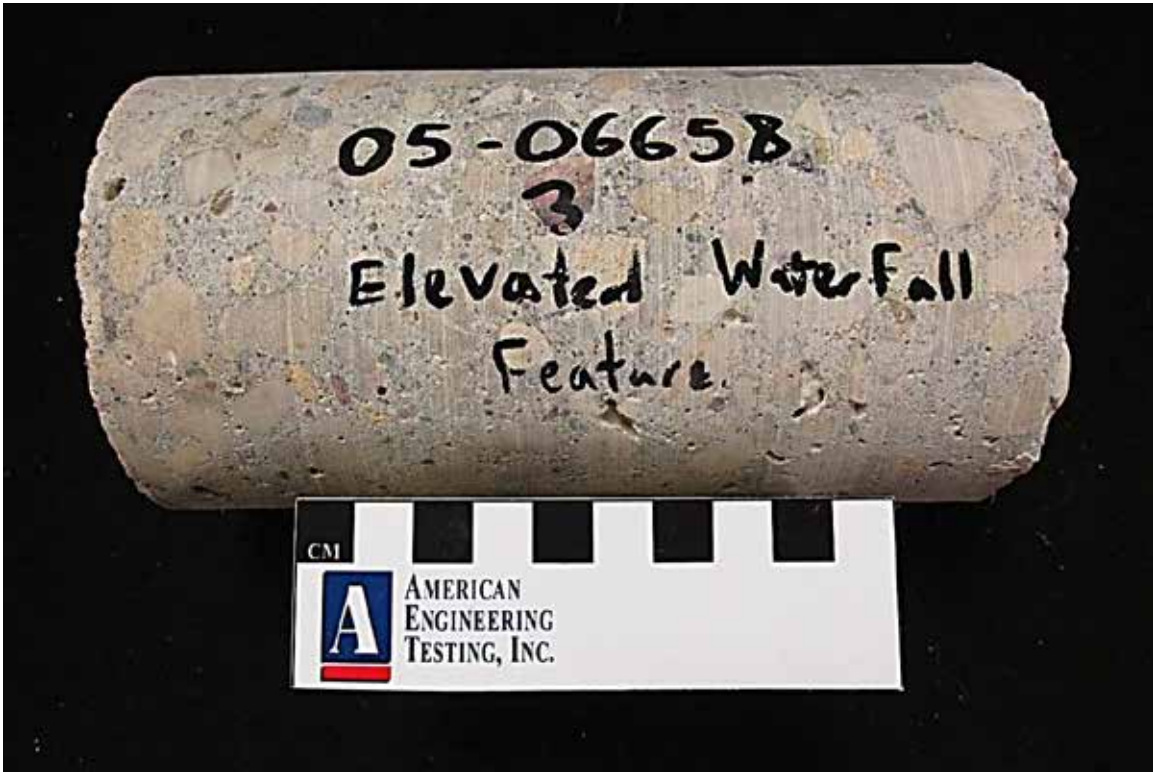
PHOTO: 5

SAMPLE ID: 3      DESCRIPTION: Overall profile of the core as received, with the outer surface oriented to the left.

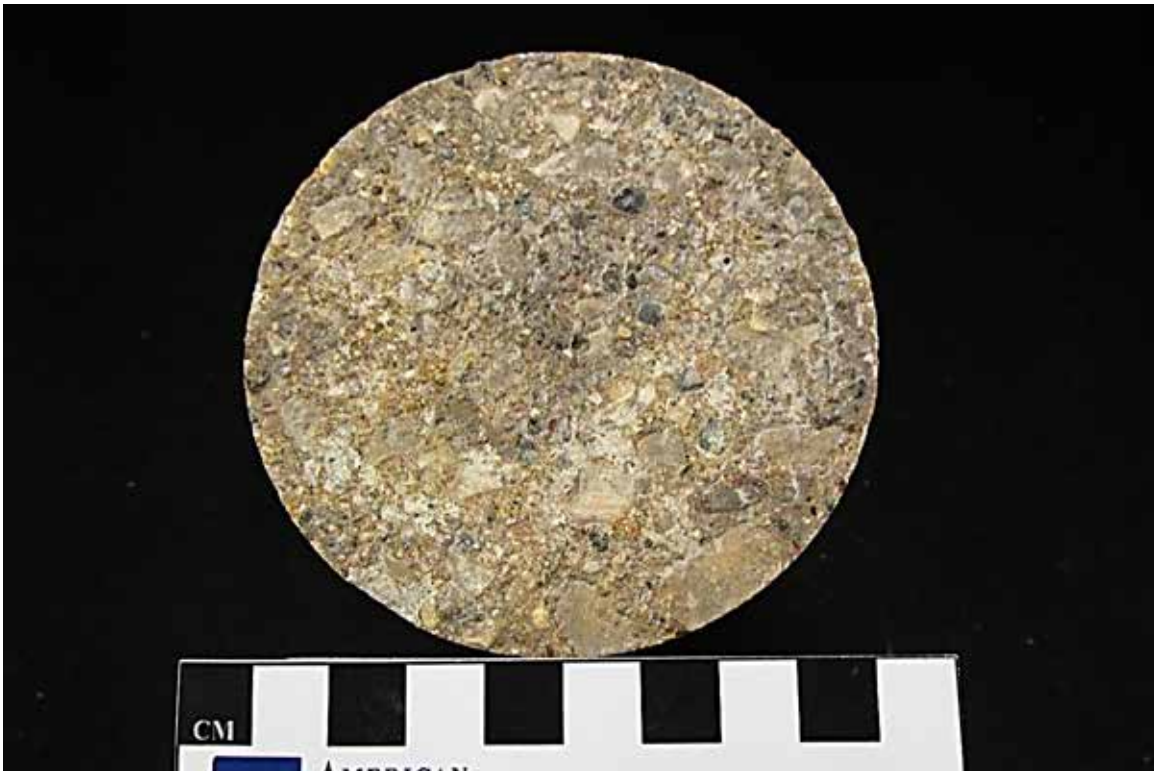
PHOTO: 6

SAMPLE ID: 3      DESCRIPTION: The outer surface of the core as received. Severe mortar erosion has exposed many coarse aggregate particles.

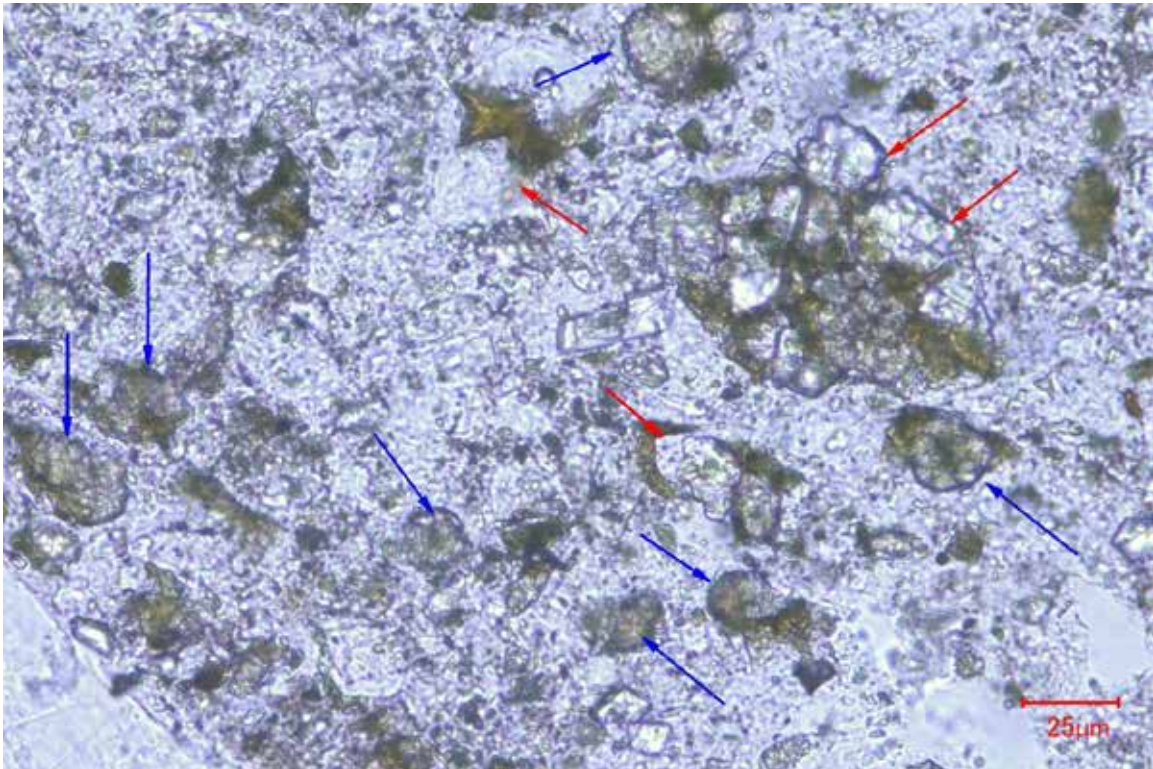
PHOTO: 7

DESCRIPTION: Moderately to fully-hydrated residual and relict alite (red arrows) and Low to moderately hydrated residual belite (blue arrows) portland cement clinker particles in a thin section of concrete paste viewed with transmitted plane-polarized light.

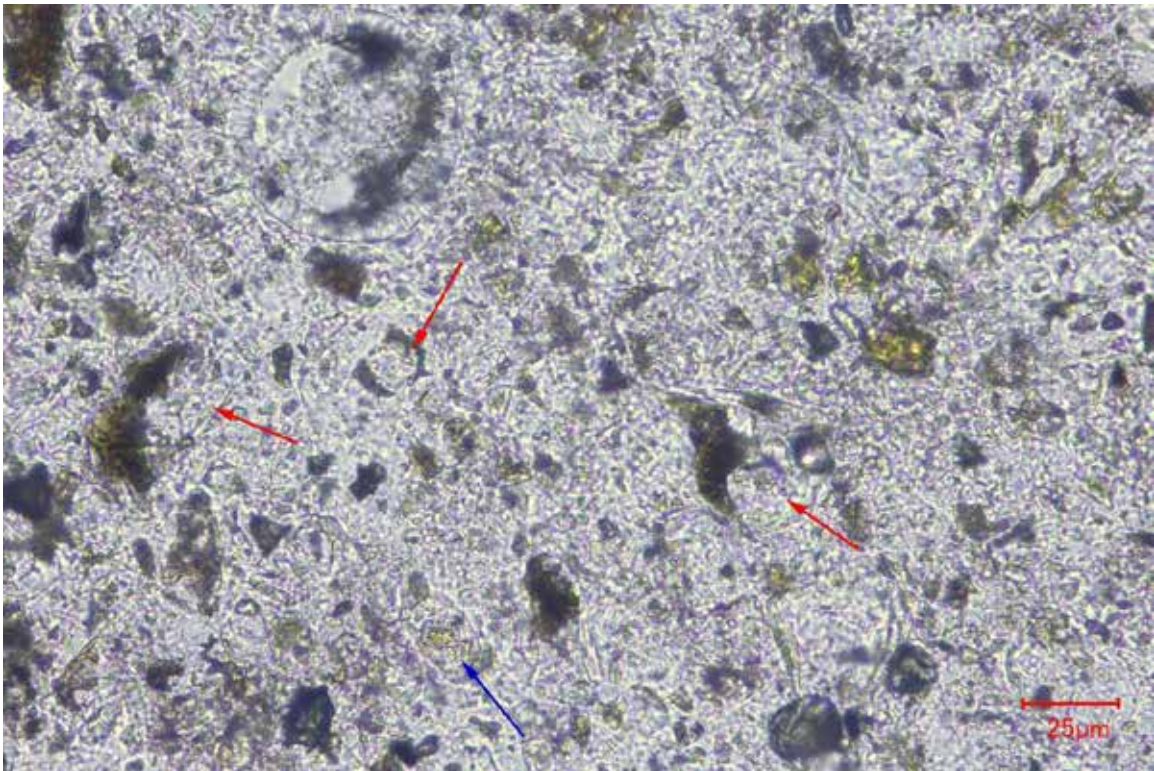
PHOTO: 8

DESCRIPTION: Fully-hydrated relict alite (red arrows) and a fully hydrated relict belite (blue arrow) portland cement clinker particles in a thin section of concrete paste viewed with transmitted plane-polarized light.

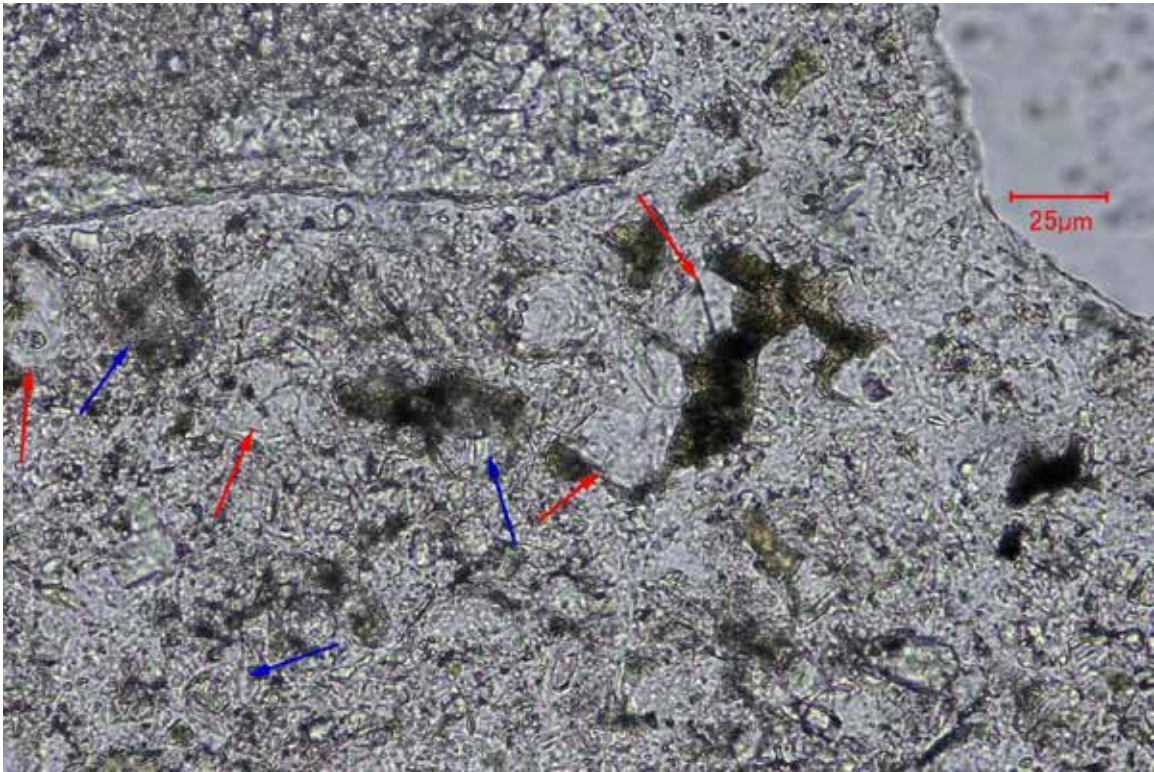
PHOTO: 9

DESCRIPTION: Fully-hydrated relict alite (red arrows) and well hydrated residual belite (blue arrows) portland cement clinker particles in a thin section of concrete paste viewed with transmitted plane-polarized light.

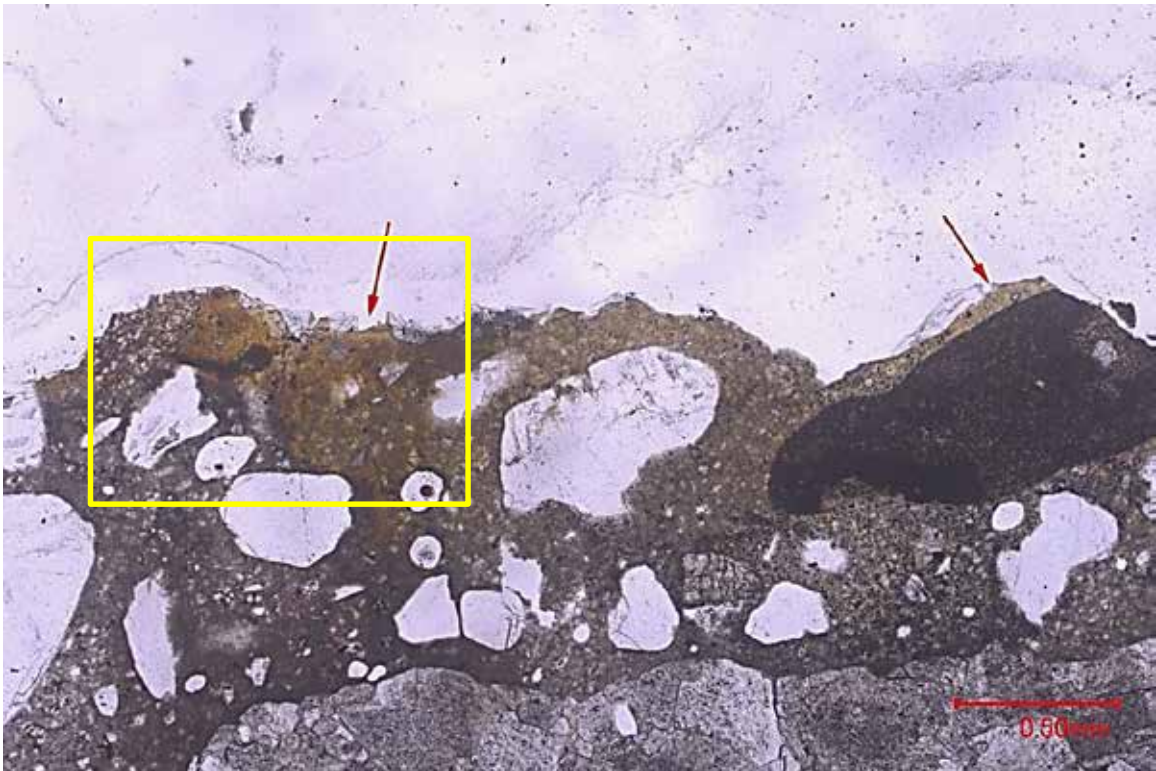
PHOTO: 10

2. Iron oxide staining observed at the outer surface of core 3 exhibited a profile, in thin section and in lapped profile, indicative of acidic attack. The top approximately 0.5 mm of the paste was very friable and was stained reddish-brown to orange-brown. The stain appears to have been produced by a combination of oxidation of iron bearing minerals within the fine aggregate and from the ferrite (iron phase) present in the portland cement. In thin section, this paste is opaque (black) when viewed with cross-polarized light and occurs directly over carbonated paste. The acid attack may be due to exposure to mildly acidic rain water; however, similar profiles have also been produced by exposure to very soft water.

DESCRIPTION: Orange-brown discoloration of the paste at the outer surface was up to 0.5 mm thick. The yellow box gives the approximate location of photos 11 and 12. Thin section of concrete viewed with transmitted plane-polarized light.

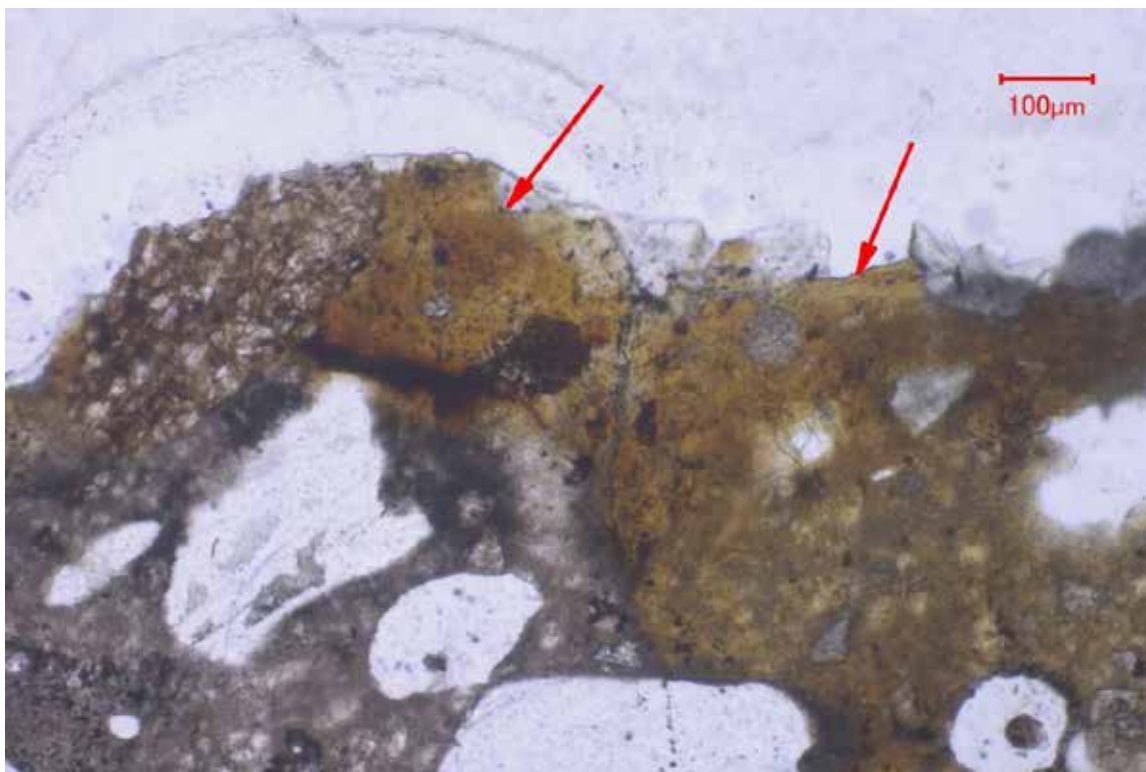
**PHOTO: 11**

**DESCRIPTION:** Magnified view of area within the yellow box in photo 10, showing stained paste. Thin section of concrete paste viewed with transmitted plane-polarized light.

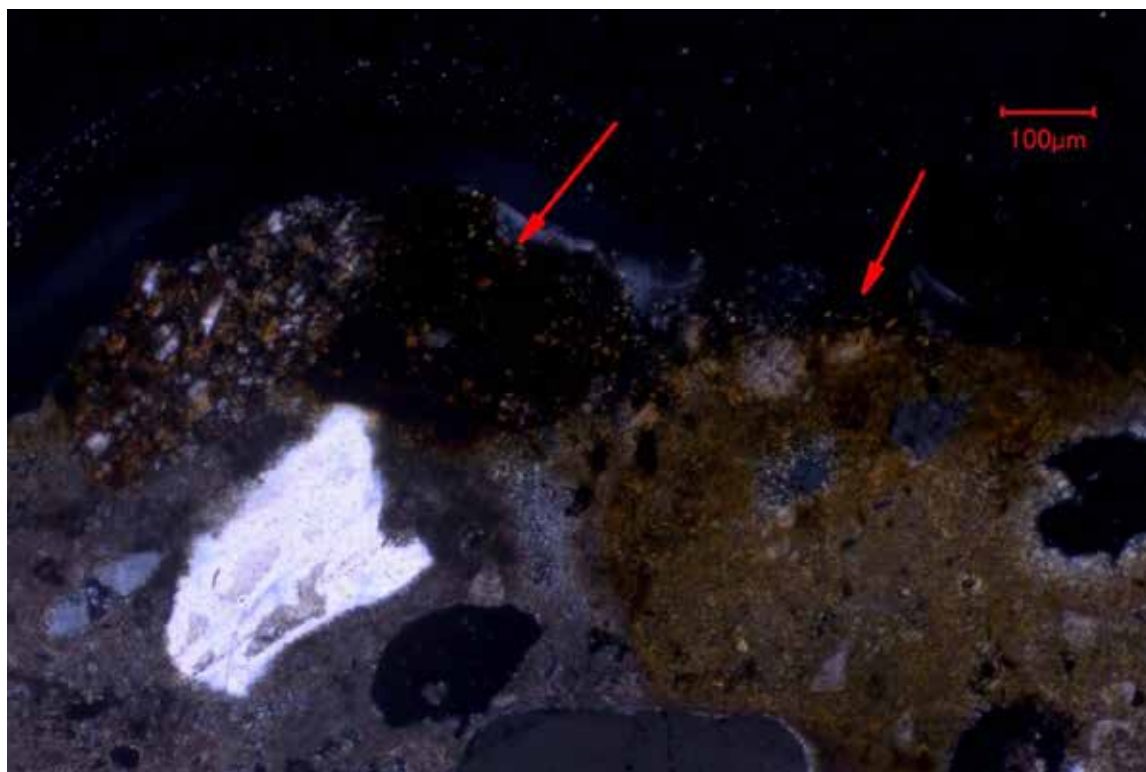
**PHOTO: 12**

**DESCRIPTION:** Same area as pictured above, viewed with transmitted cross-polarized light. The top most stained paste is opaque (black). The carbonated paste beneath is stained on the right side of the photomicrograph and unstained on the left side. A layer of opaque paste is typically observed in concrete that has experienced acid attack.

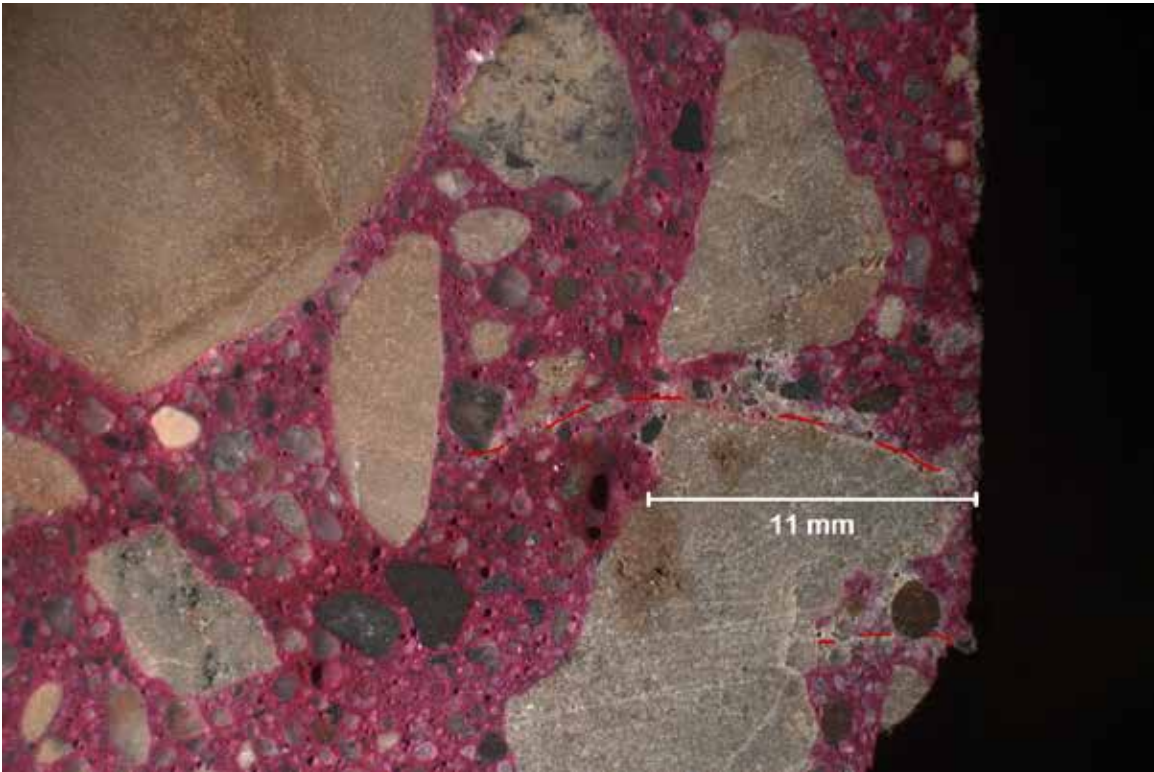
PHOTO: 13

**DESCRIPTION:** Carbonation (unstained paste) measured from the outer surface of the core was mostly negligible and proceeded up to 11 mm (7/16") depth along microcracking (approximated by the dashed red lines). Observed on a saw-cut and lapped profile of the sample treated with the pH indicator phenolphthalein.

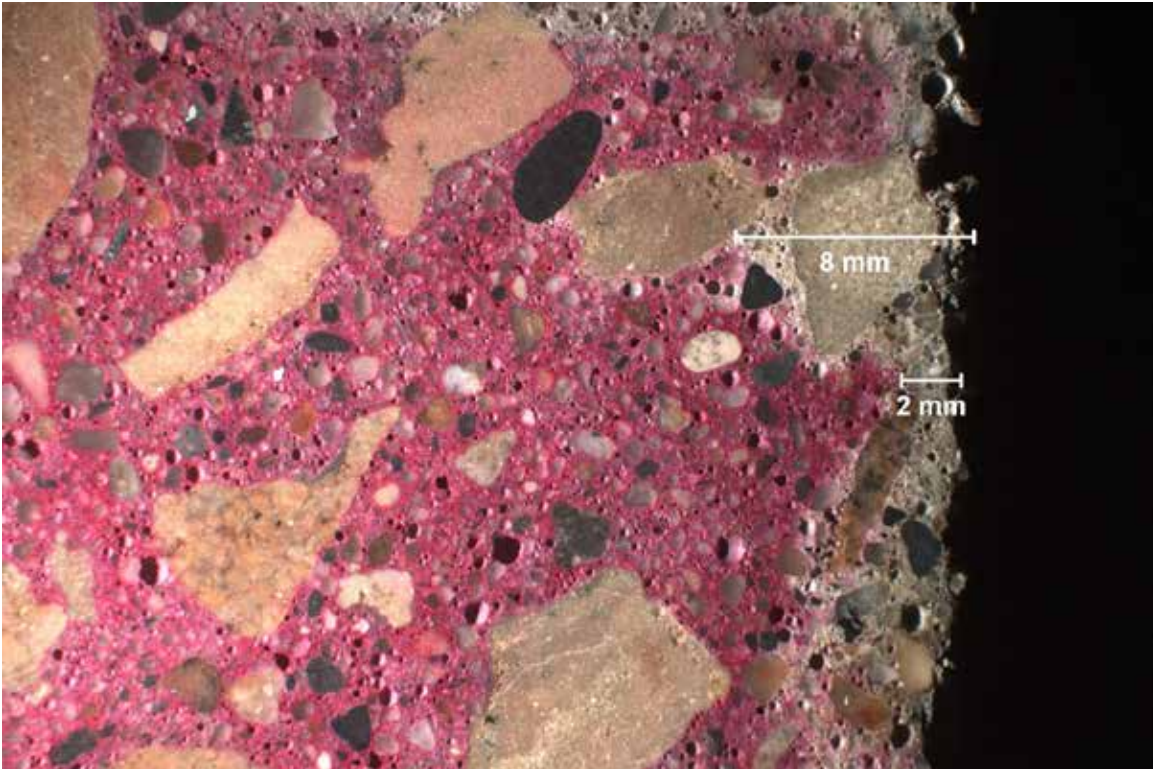
PHOTO: 14

**DESCRIPTION:** Carbonation (unstained paste) ranged from 2 mm (1/16") to 8 mm (5/16") depth from the outer surface of the sample. Observed on a saw-cut and lapped profile of the concrete treated with the pH indicator phenolphthalein.

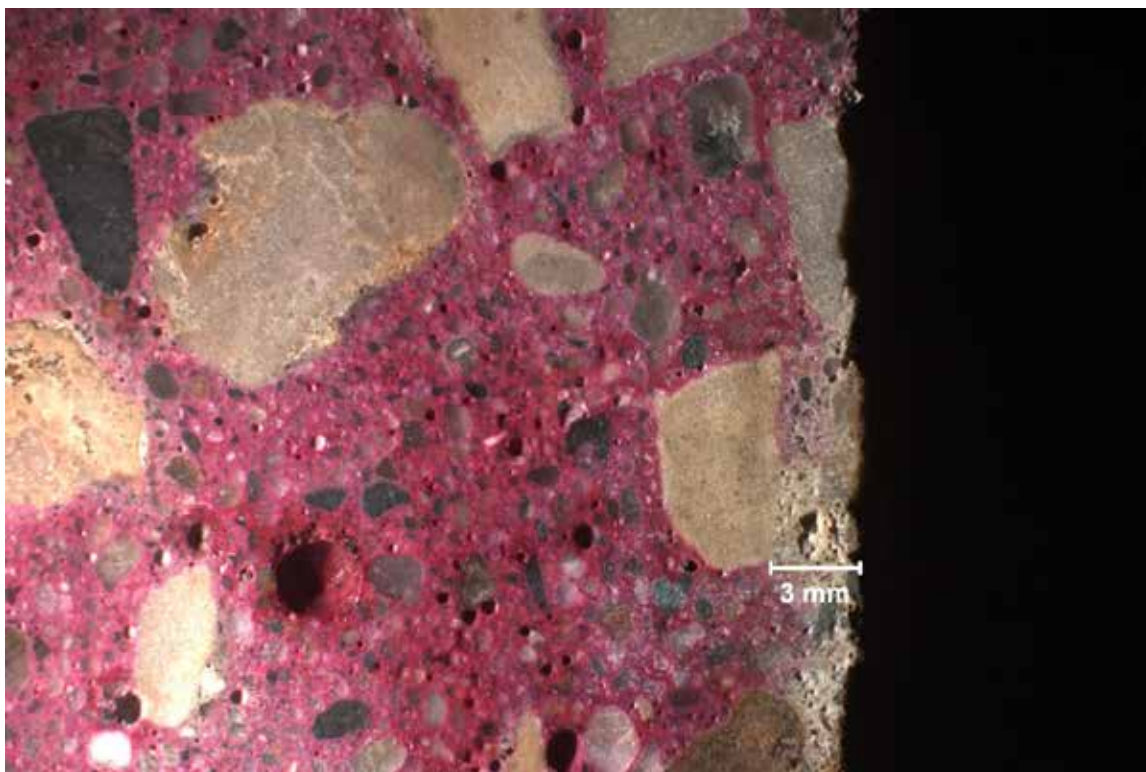
**PHOTO: 15**

**DESCRIPTION:** Carbonation (unstained paste) ranged from negligible to 3 mm (1/8") depth from the outer surface of the sample. Observed on a saw-cut and lapped profile of the concrete treated with the pH indicator phenolphthalein.

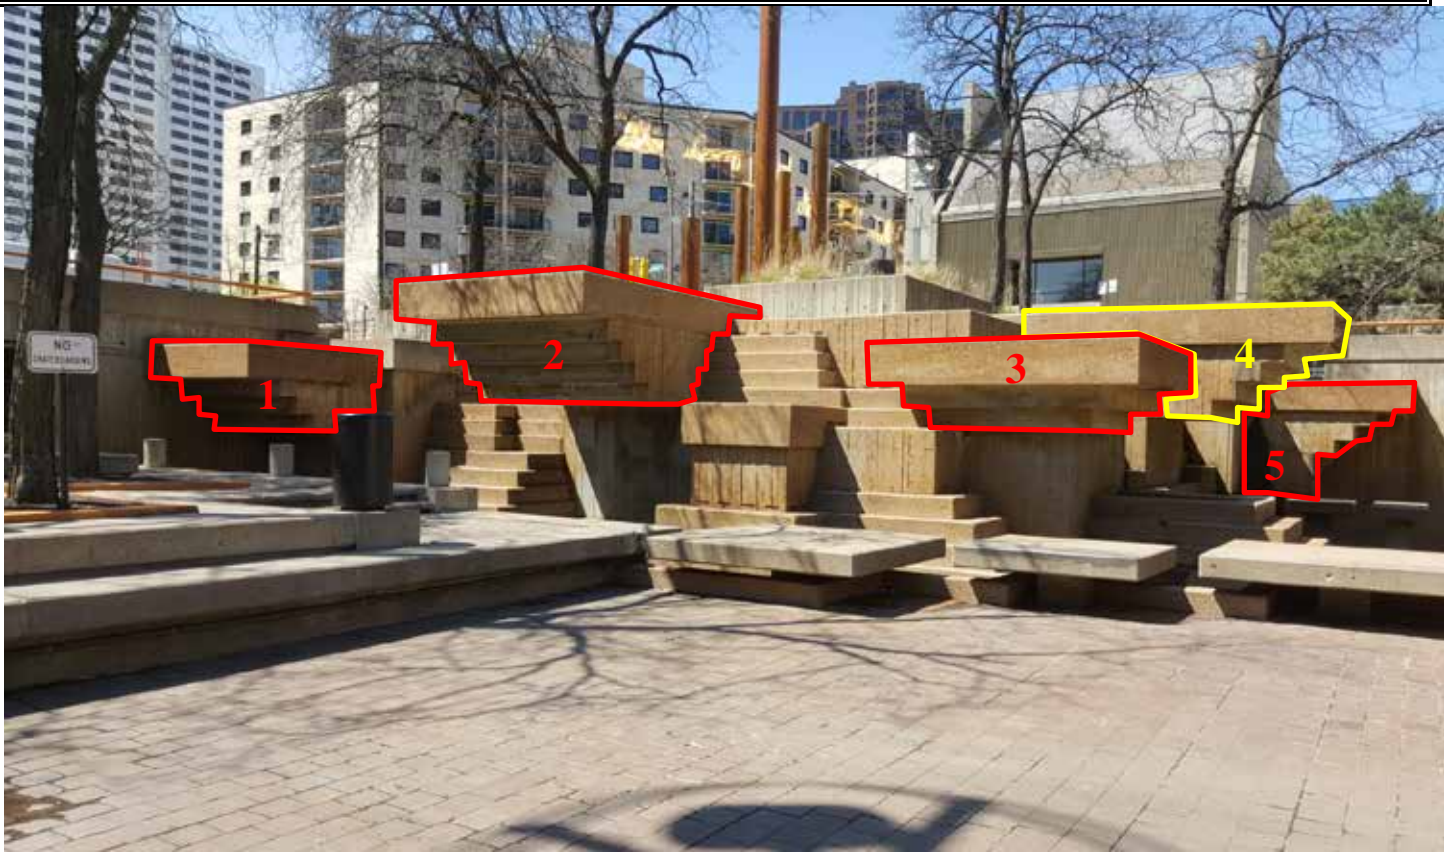
**Photo 1:** Facing Nicollet Avenue. The overhangs are numbered from 1 to 5 in the following photos depicting concrete cover.

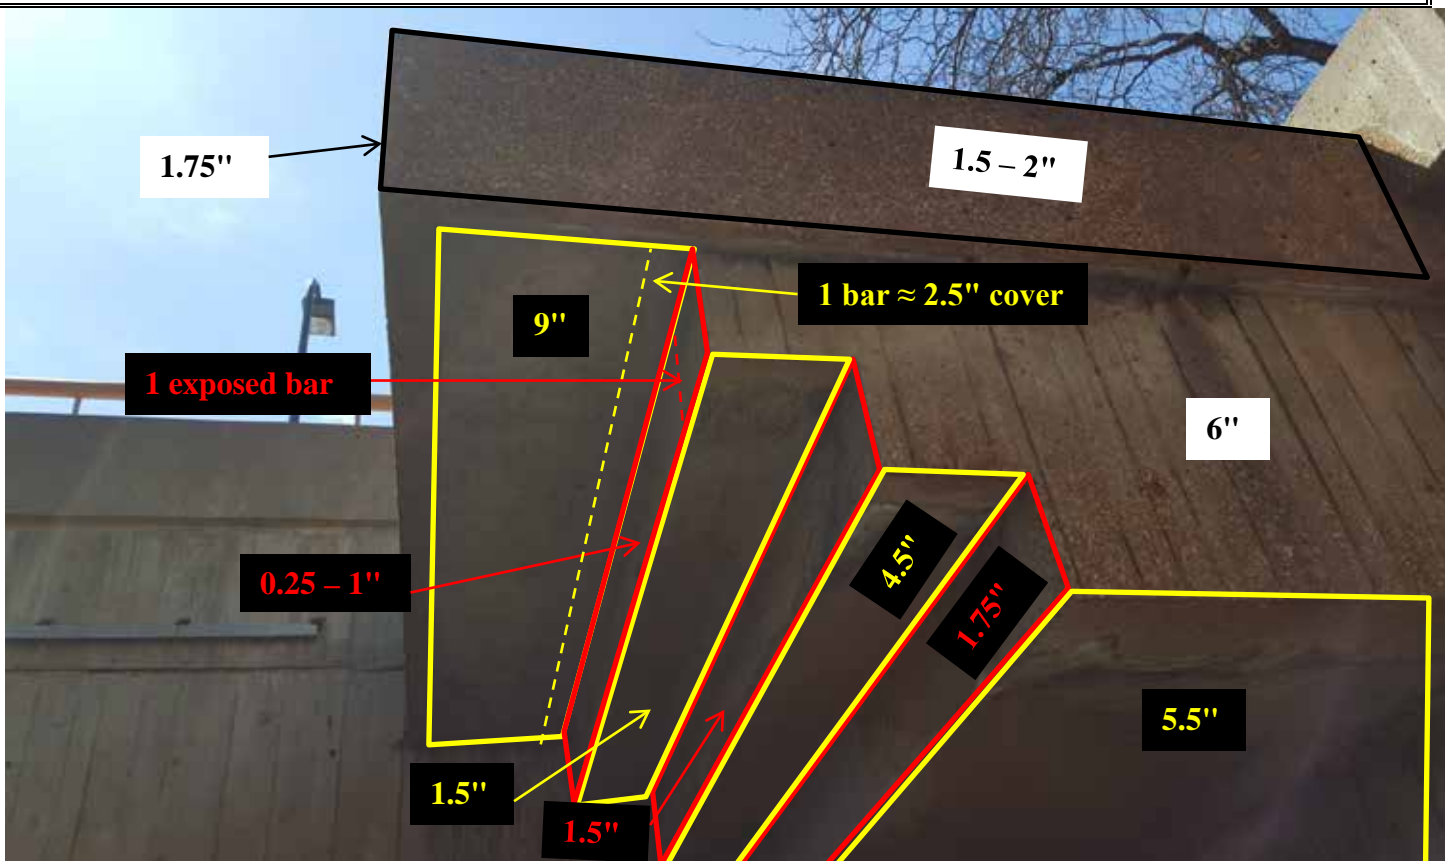
**Photo 2:** Overhang 1 – Facing 12th Street South.

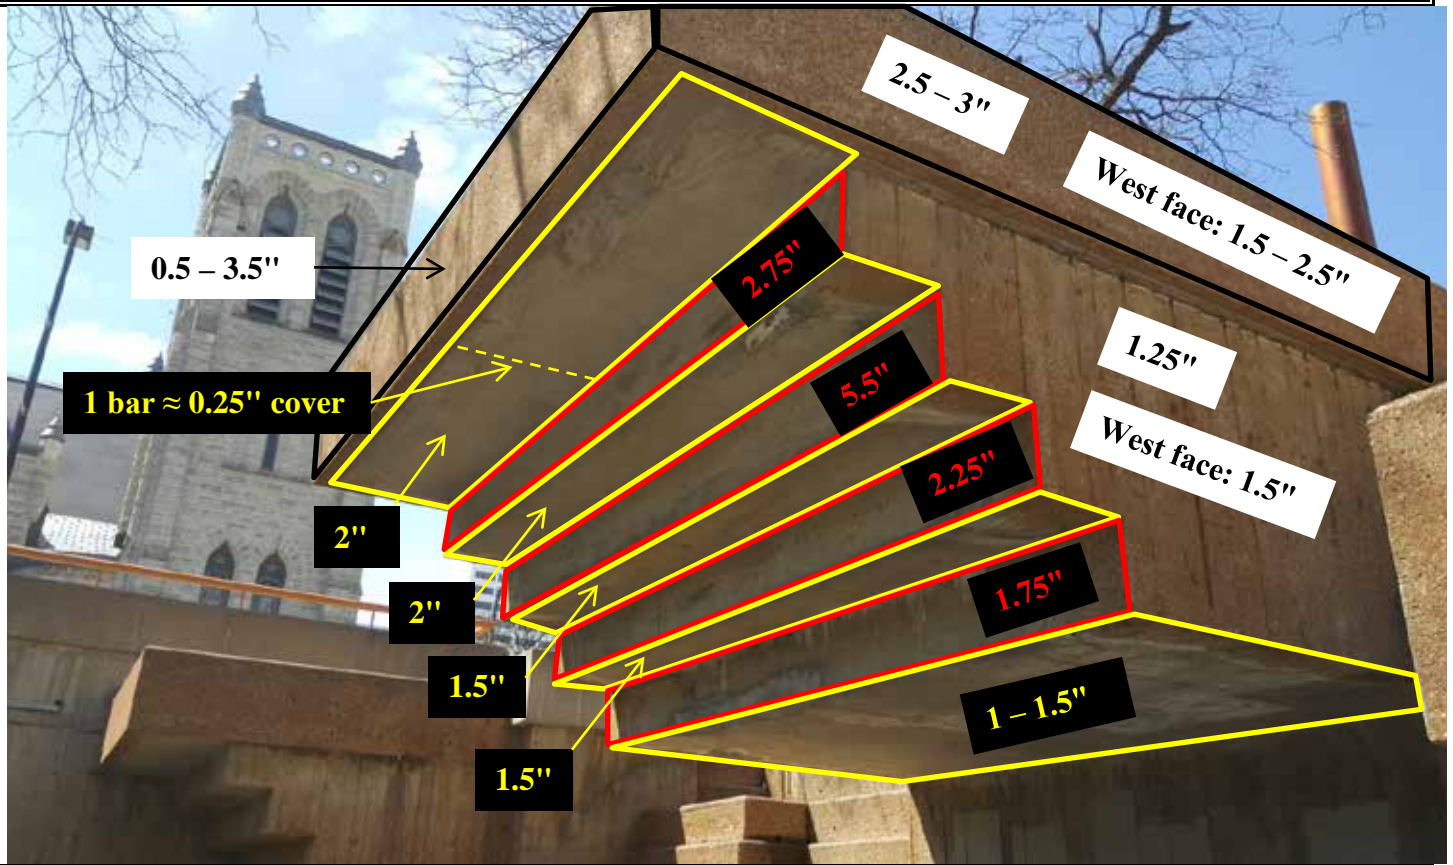
**Photo 3:** Overhang 2 – Facing 12th Street South

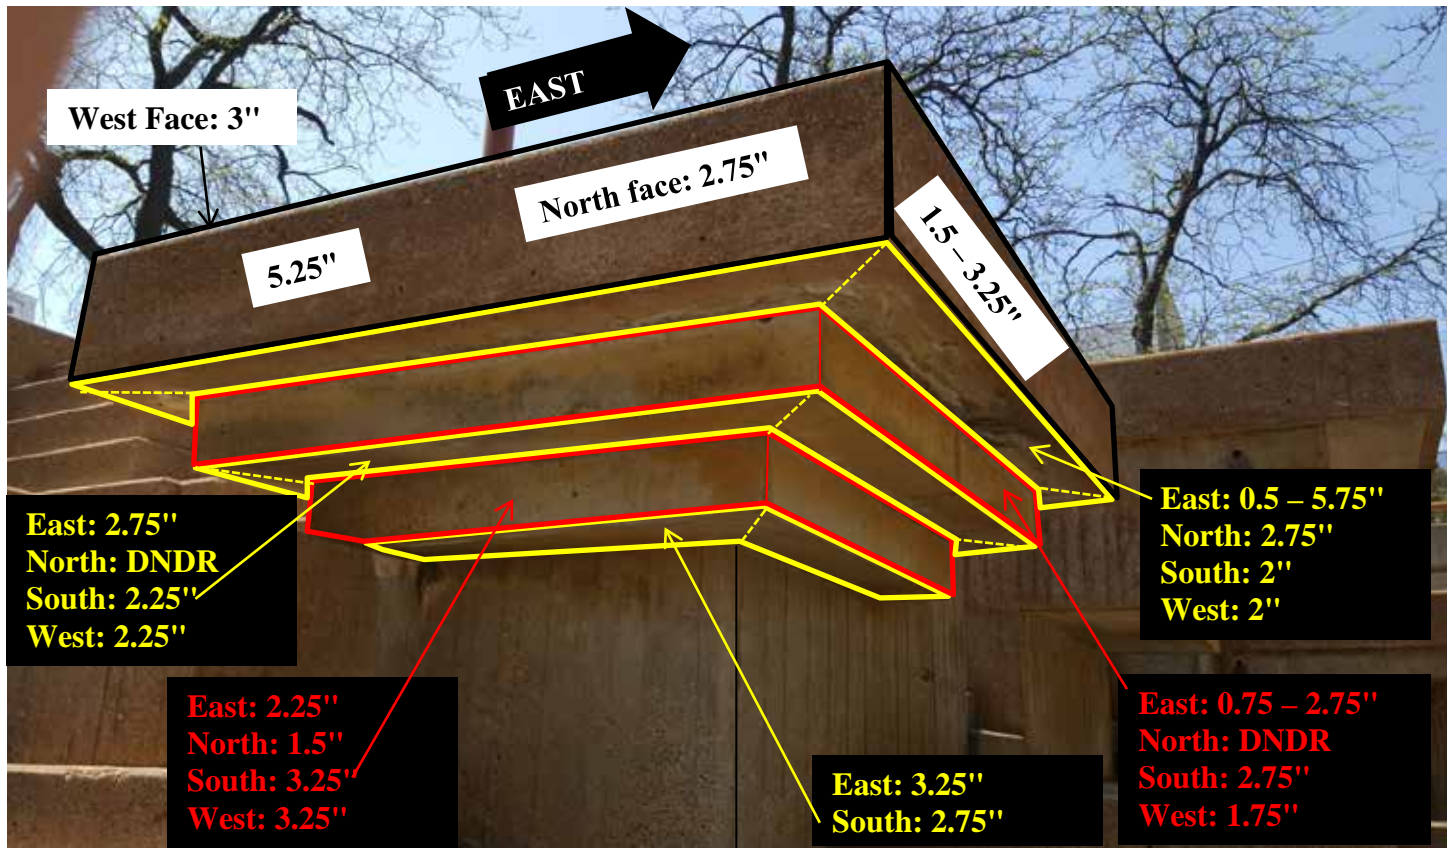
**Photo 4:** Overhang 3 – Facing Nicollet Avenue. DNDR – Did Not Detect Reinforcement

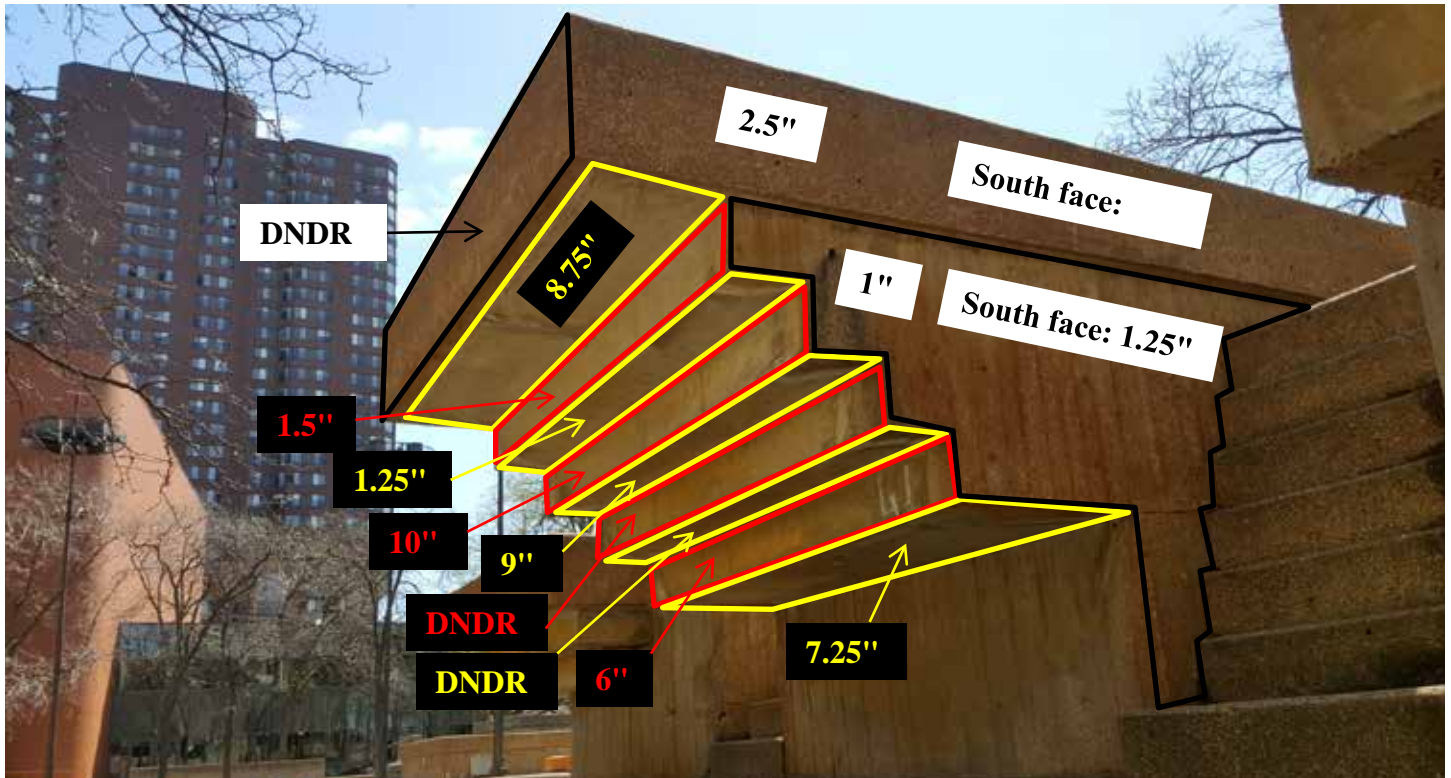
**Photo 5:** Overhang 4 – Facing Marquette Avenue. DNDR – Did Not Detect Reinforcement

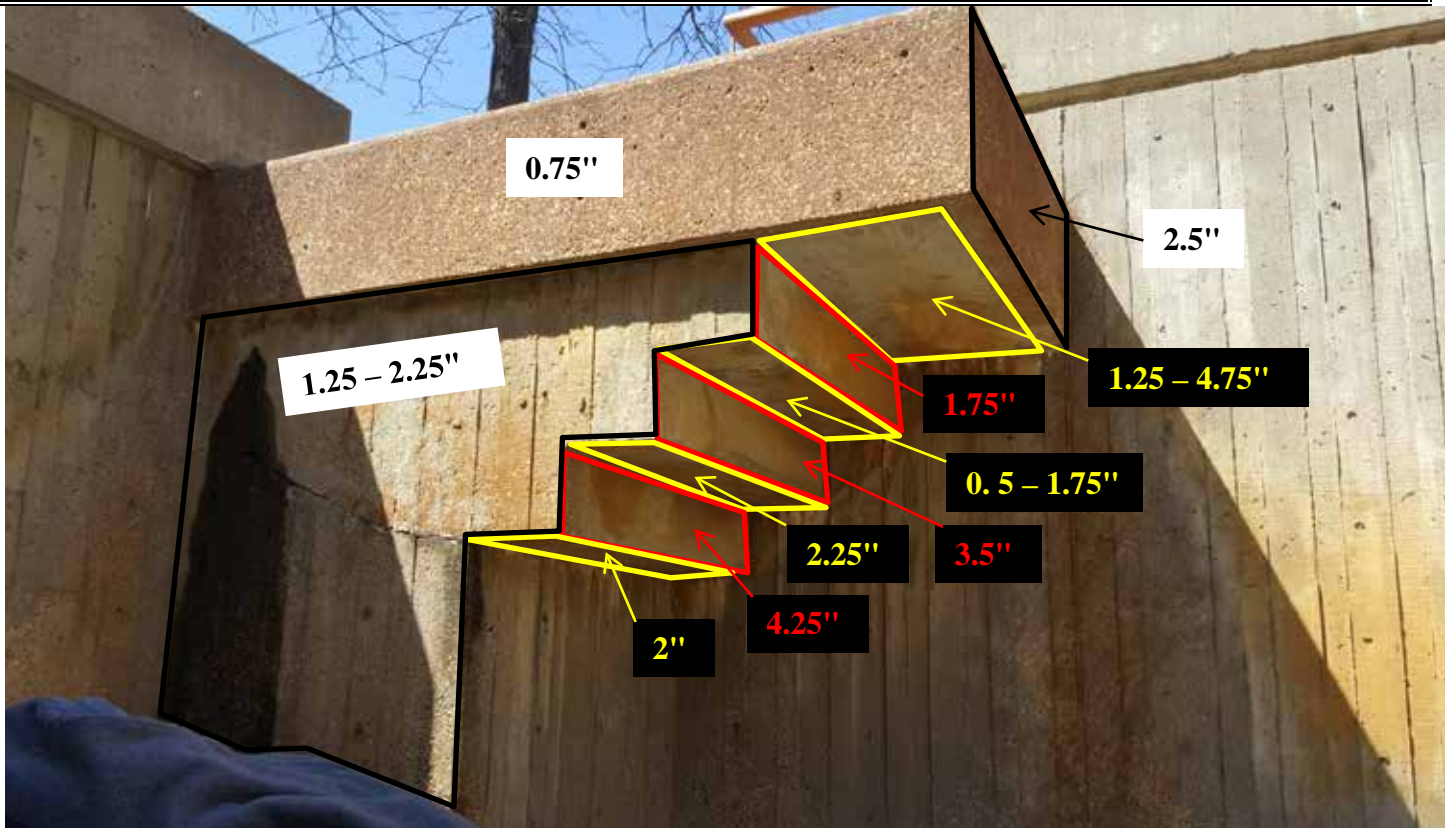
**Photo 6:** Overhang 5 – Facing Nicollet Avenue.

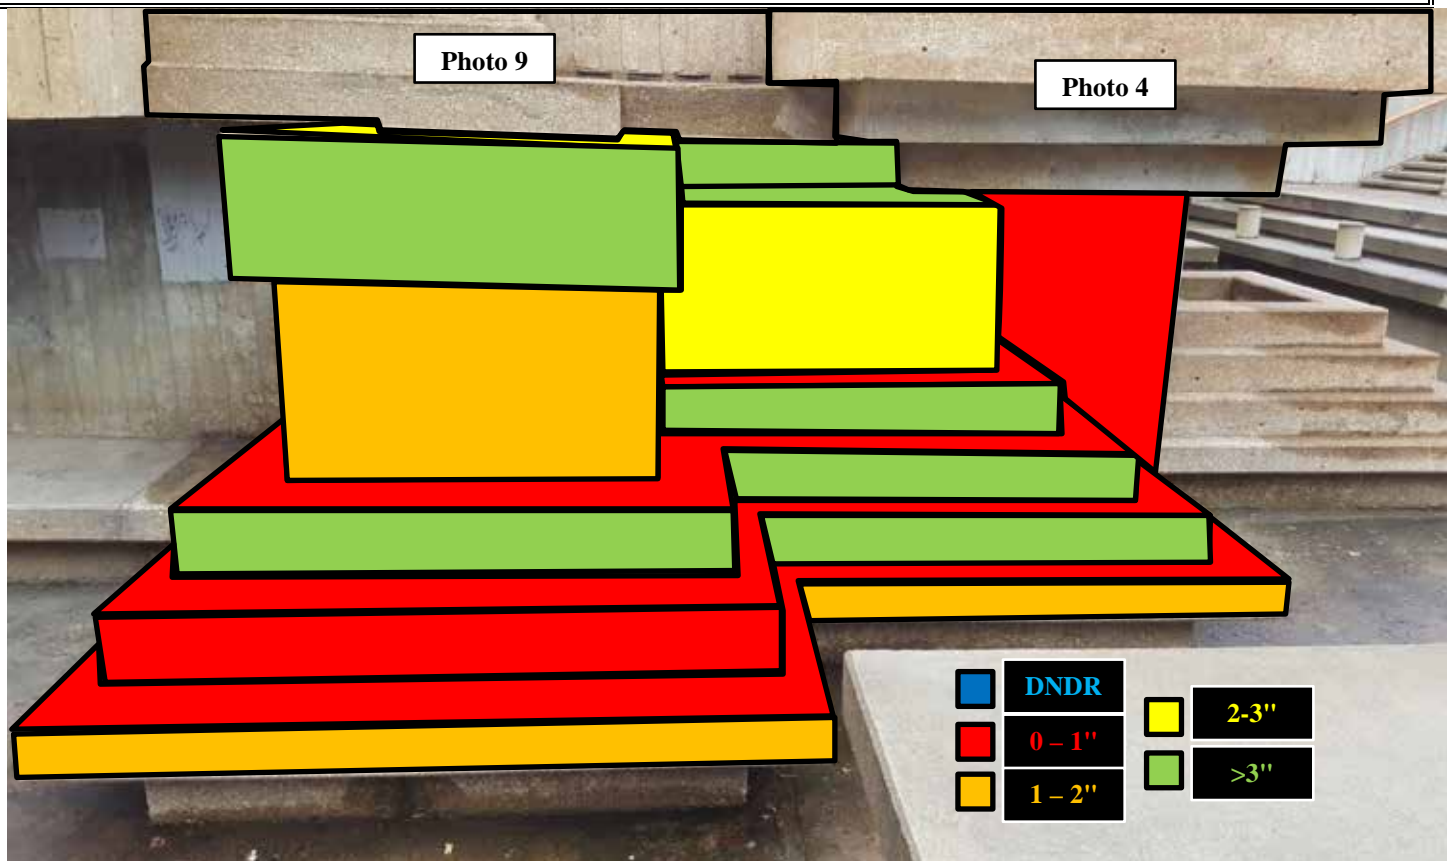
**Photo 8:** Facing Nicollet Avenue toward the south "fountain steps" near the southeast corner of the fountains.
